**CONSENT ORDER
ISSUED UNDER THE
WATER POLLUTION CONTROL ACT
WEST VIRGINIA CODE, CHAPTER 22, ARTICLE 11**

TO: MarkWest Liberty Midstream & Resources, L.L.C. DATE: March 28, 2019
Gregory Bezdek, SVP, NE Region
4600 J Barry Ct. Ste 500
Canonsburg, PA 15317 ORDER NO.: 8945

MARKWEST LIBERTY MIDSTREAM & RESOURCES, L.L.C, WVR311004, Sherwood to Mobley
20" NGL, 8/22 & 8/23/2018

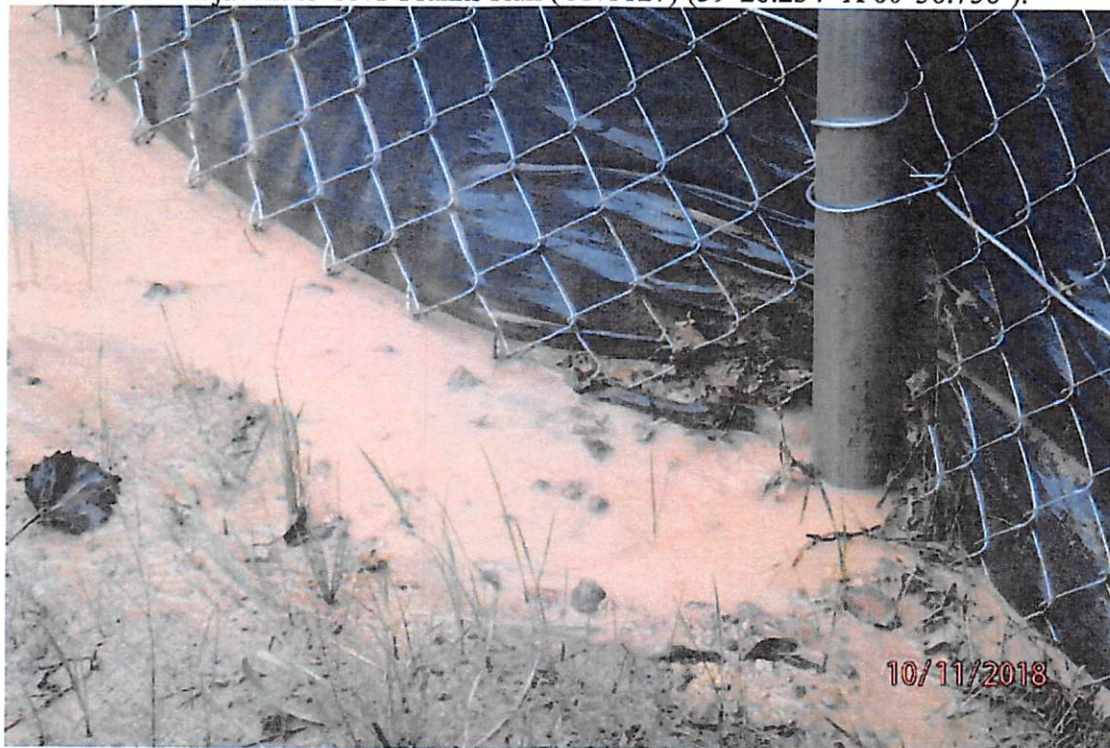
Perimeter controls in need of maintenance that are allowing sediment laden water to bypass under the device adjacent to UNT Franks Run (UNT127) (39°26.234' X 80°36.756').

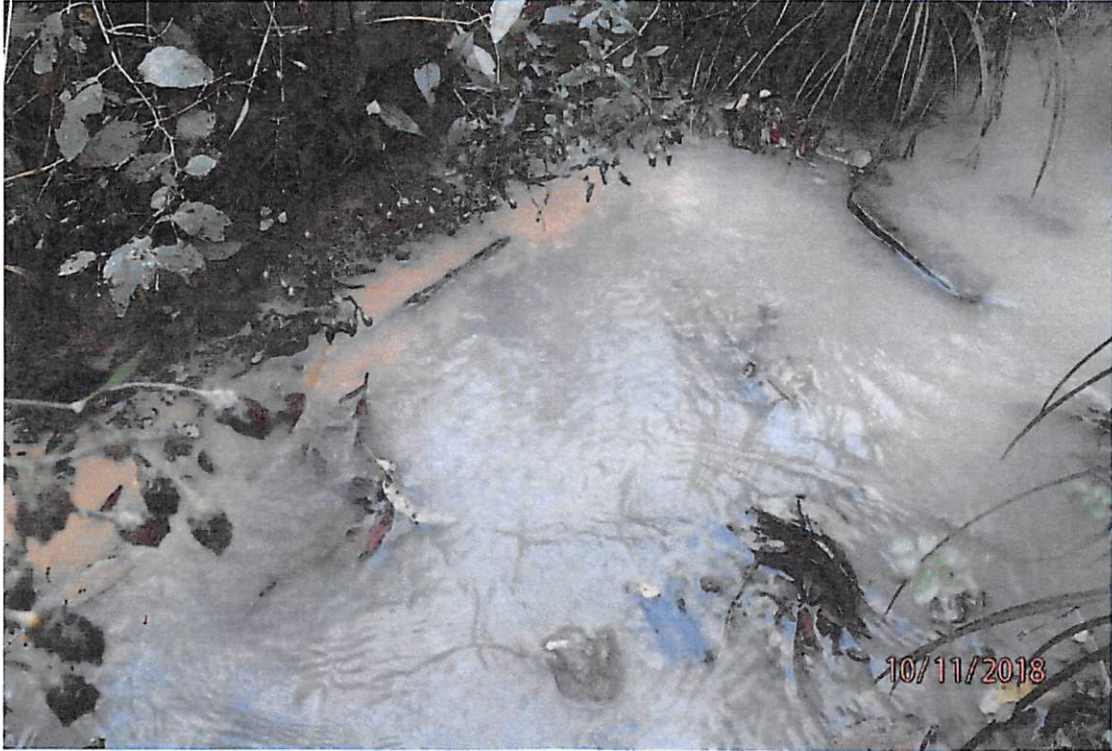
Offsite CNA distinctly visible settleable solids in UNT Franks Run (UNT127) (39°26.234' X 80°36.756').

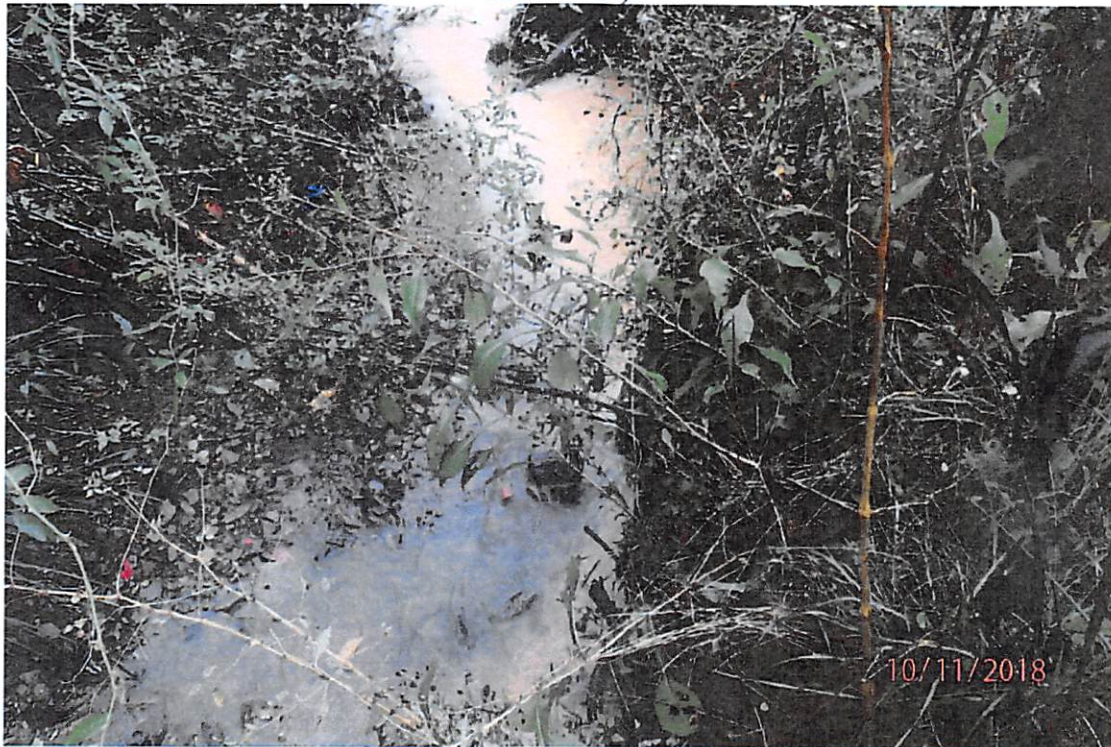
Offsite CNA distinctly visible settleable solids in UNT Franks Run (UNT127) (39°26.234' X 80°36.756').

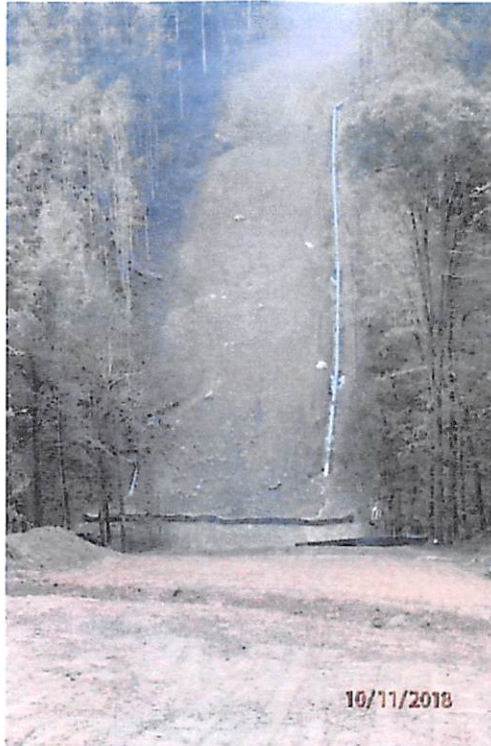
Open pipe trench adjacent to UNT 21 that is placing concentrated flow over a fill slope and overwhelming the installed perimeter controls adjacent to the stream.

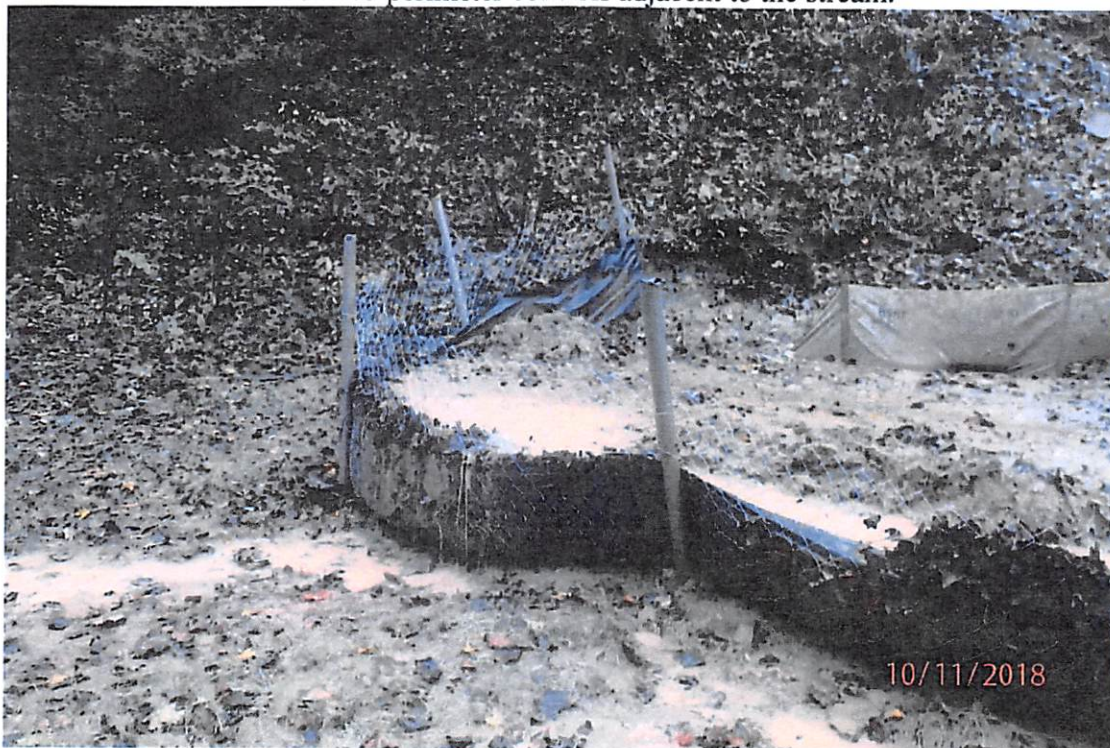
Perimeter controls adjacent to UNT 21 that are overwhelmed from trench water and a lack of maintenance.

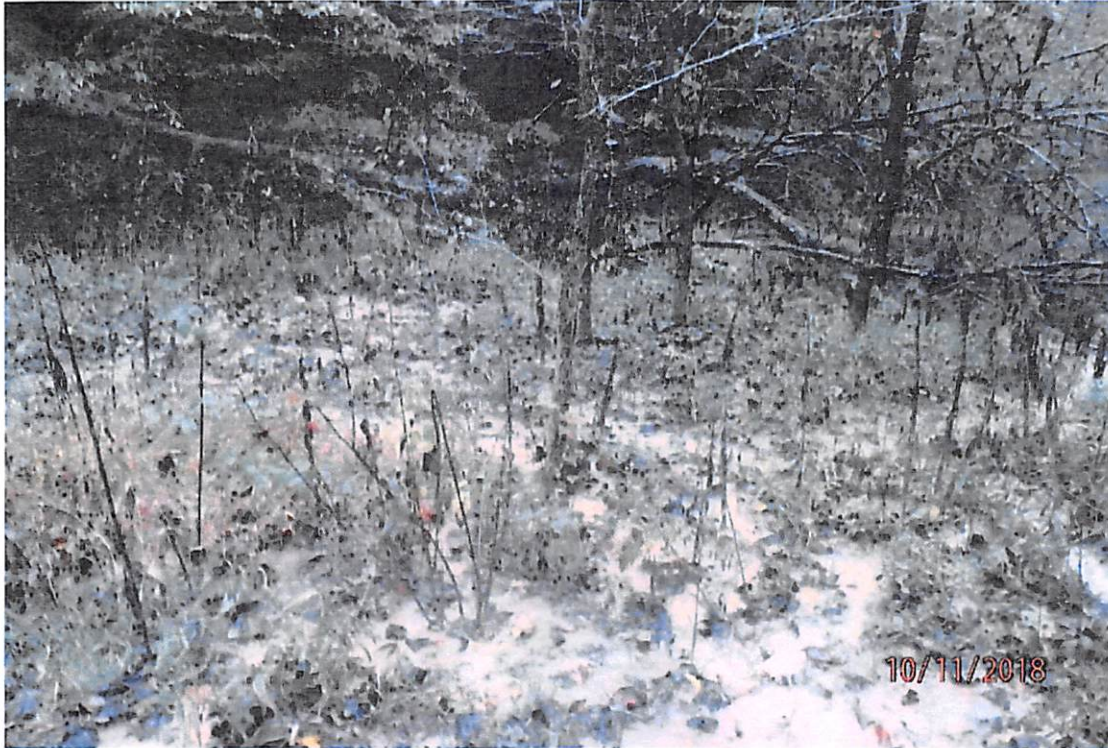
Offsite sediment laden water draining to the receiving stream (UNT 21).

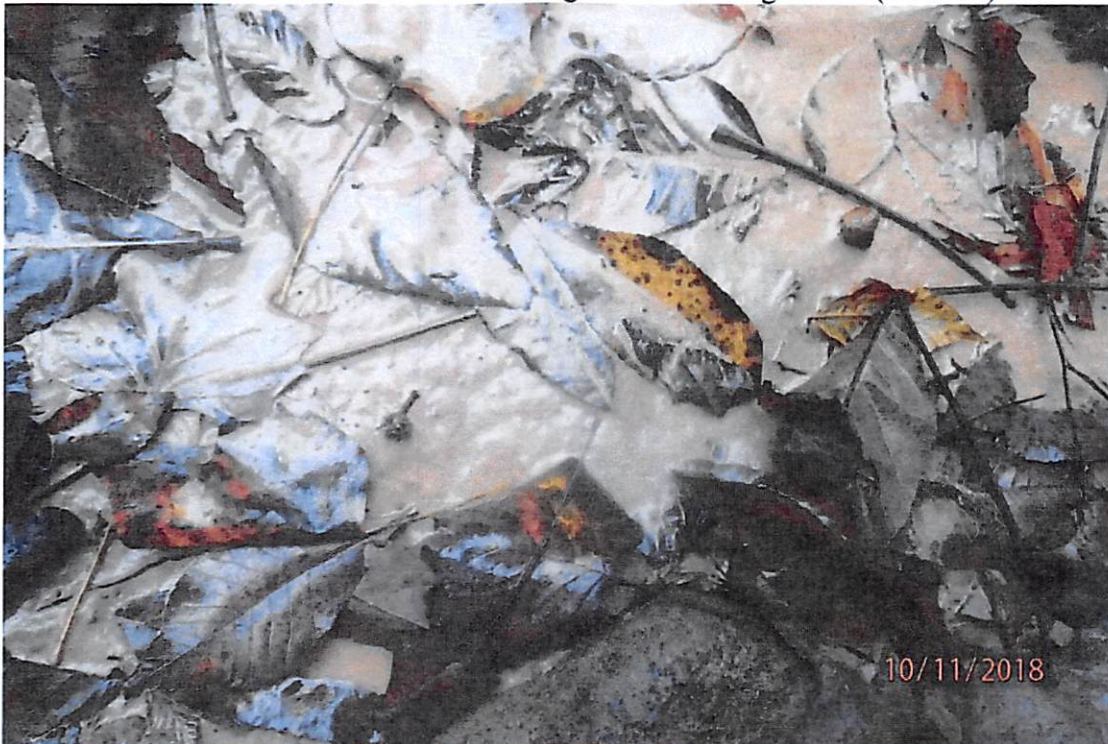
Offsite CNA deposits in UNT Beverlin Fork (UNT 21) (39°26.296' X 80°36.165').

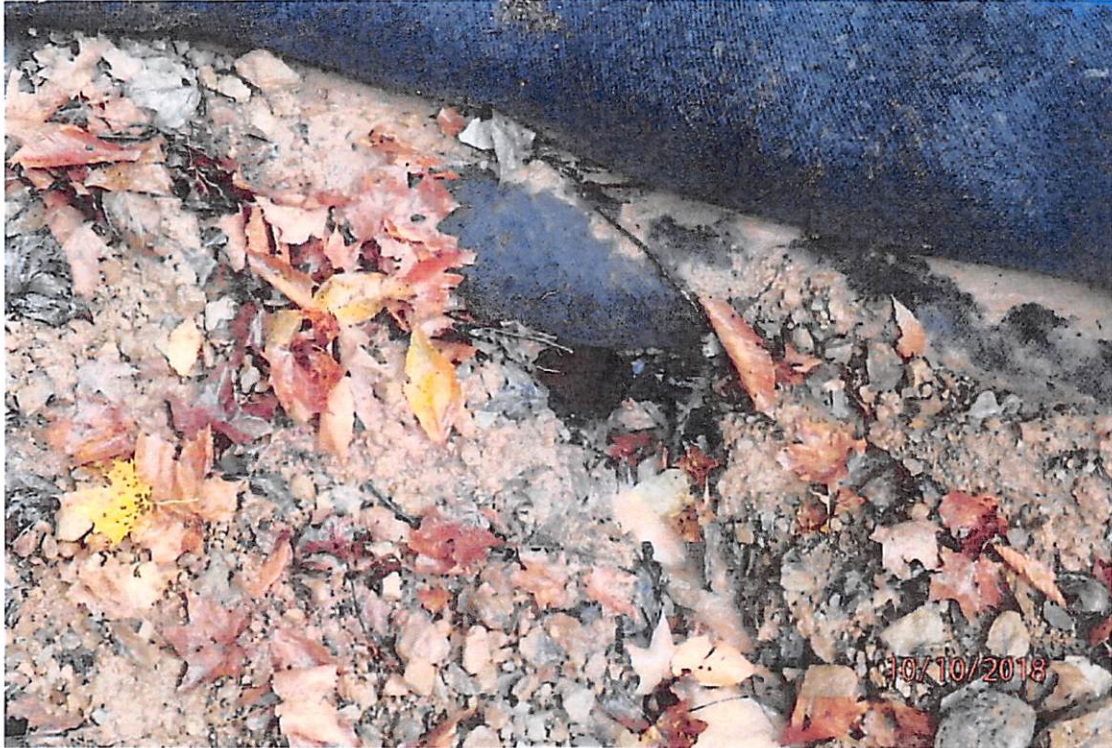
Sediment laden water bypassing under installed water bar terminus BMP adjacent to UNT Riggins Run (39°21.443' X 80°39.489').

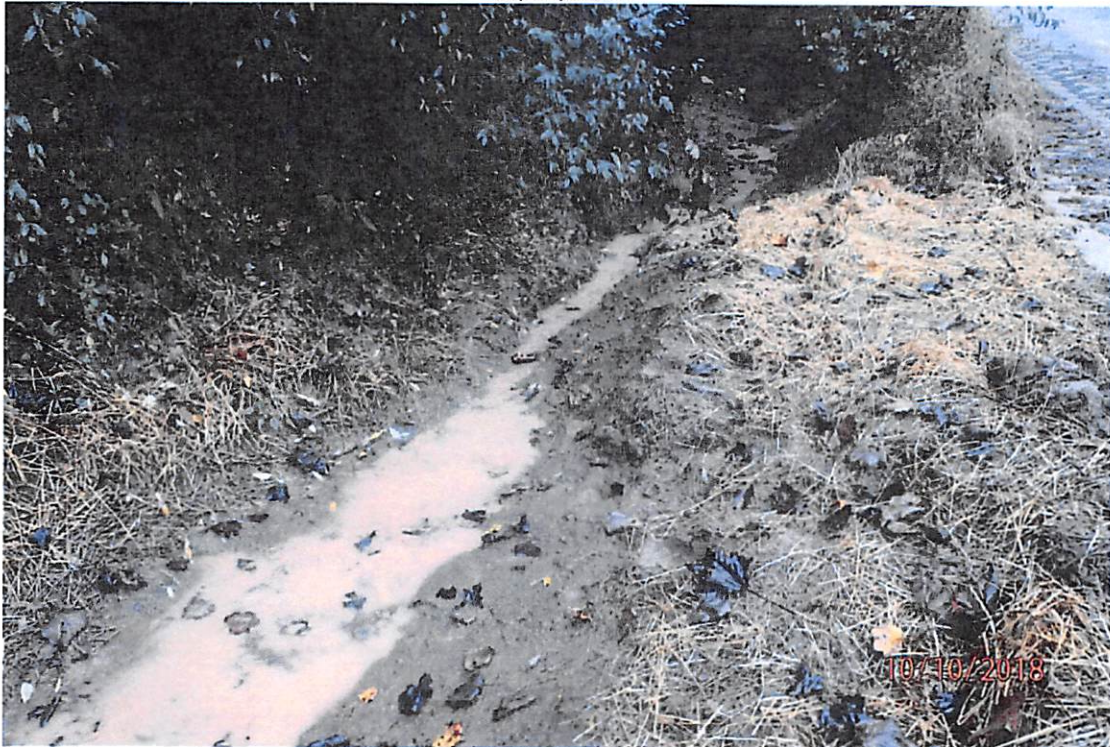
Sediment laden water in diversion along AR 18 going offsite and into UNT Riggins Run (39°21.443' X 80°39.489') contributing to CNA along with previously pictured water bar terminus BMP bypass.

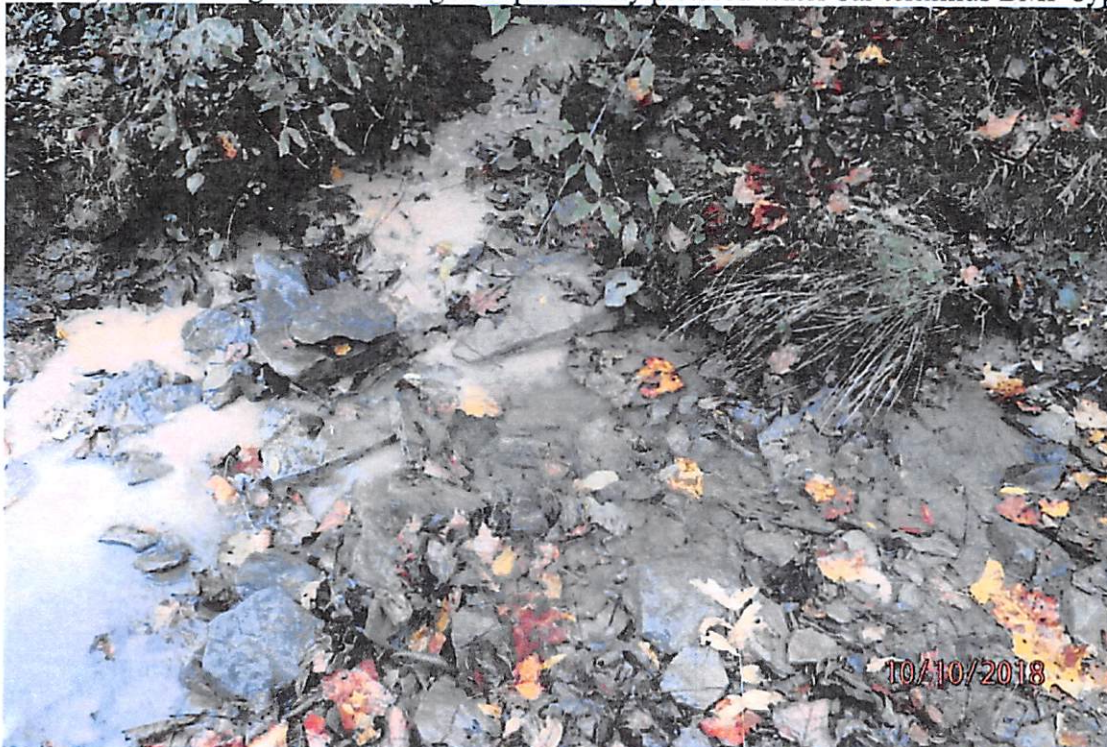
Ephemeral UNT Riggins Run (39°21.443' X 80°39.489') at its convergence with UNT Riggins Run showing distinctly visible plume.

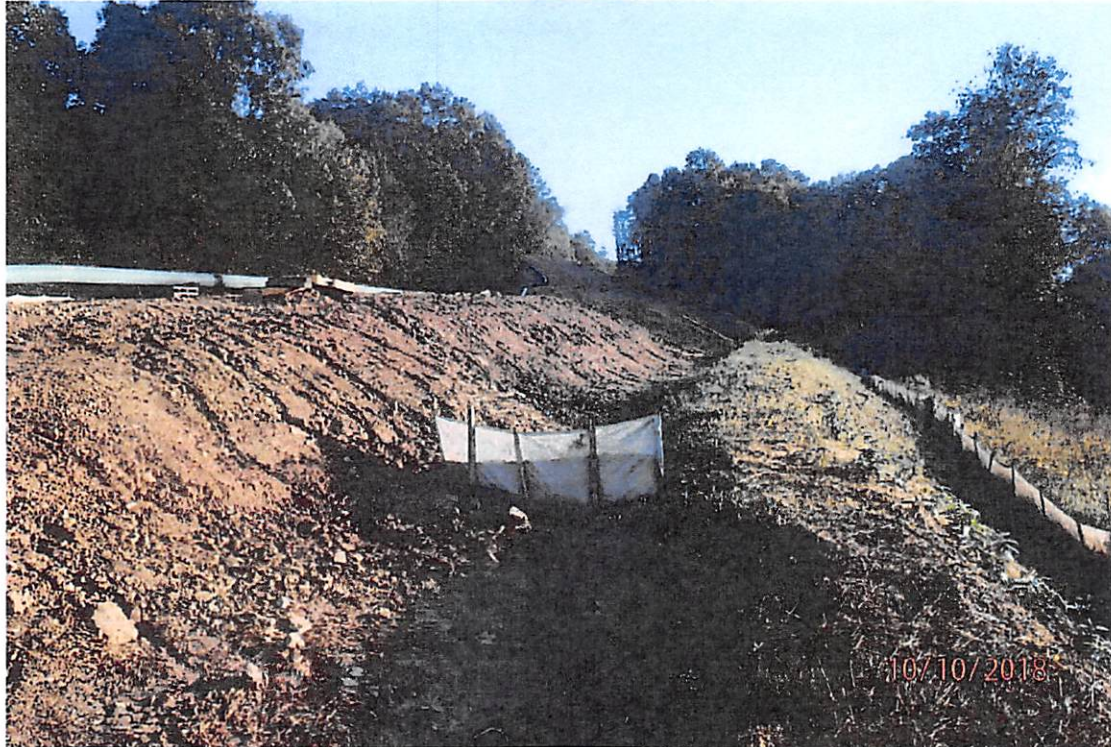
Installed diversion berm that lacks adequate outlets and is causing offsite sediment deposits due to overwhelmed outlet BMPs near 56+00.

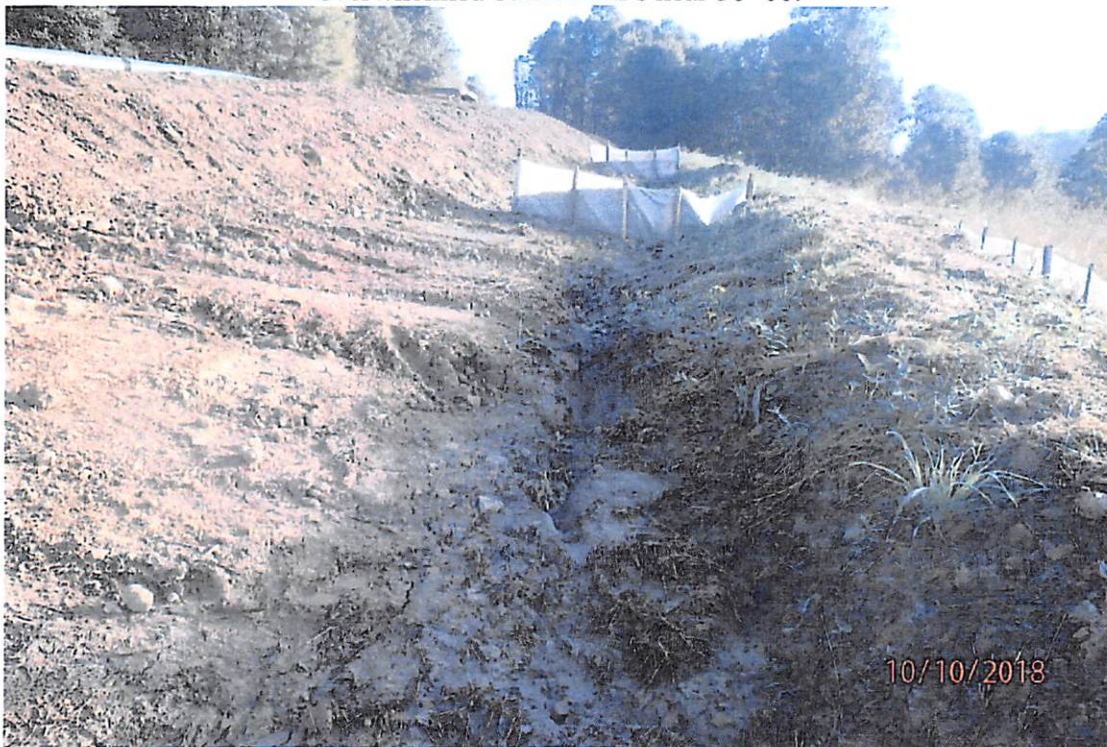
Installed diversion berm that lacks adequate outlets and is causing offsite sediment deposits due to overwhelmed outlet BMPs near 56+00.

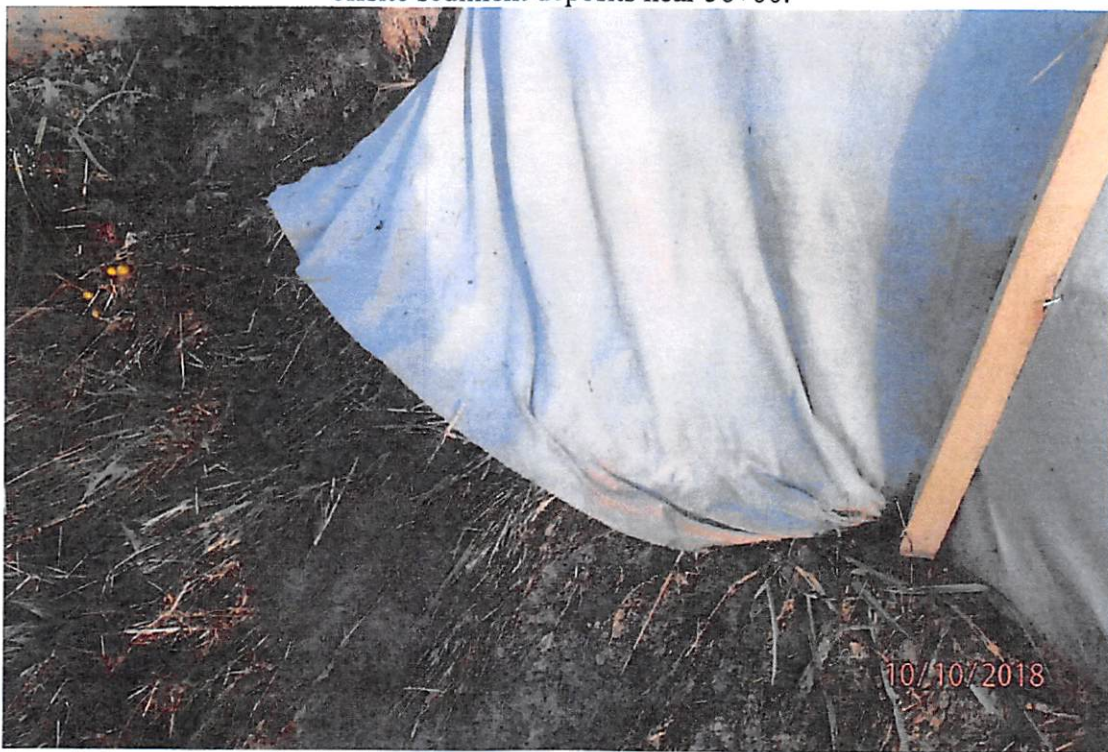
View of above pictured BMP from downslope showing its need for maintenance near 56+00.

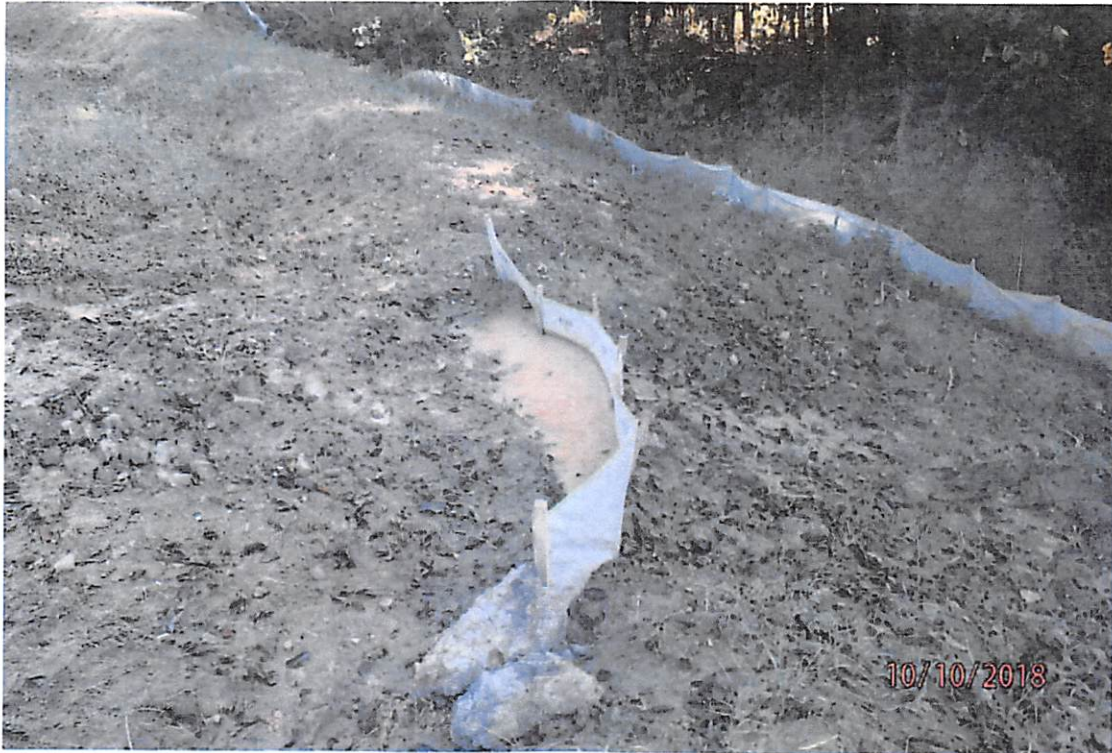
Diversion berm outlet with installed silt fence near 69+00.

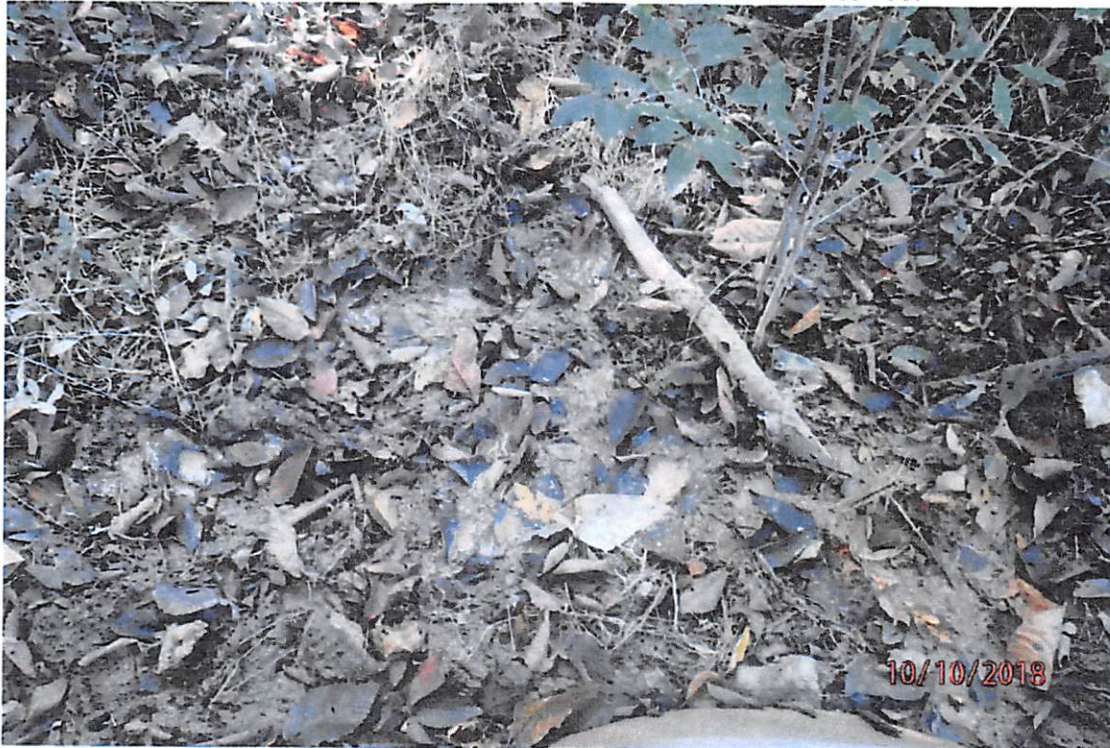
Diversion berm outlet at edge of LOD showing offsite sediment deposits due to poor maintenance and excessive flow being directed at the device near 69+00.

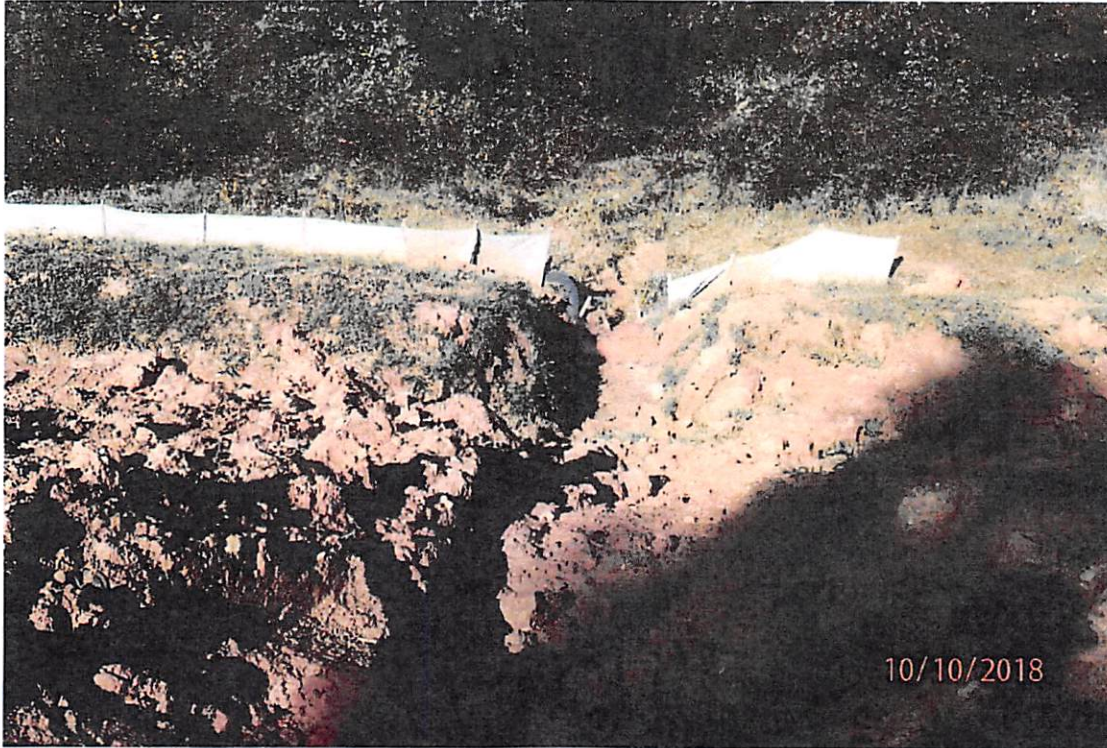
Diversion berm outlet BMP that has been overwhelmed and is in need of maintenance with associated offsite sediment deposits near 132+00.

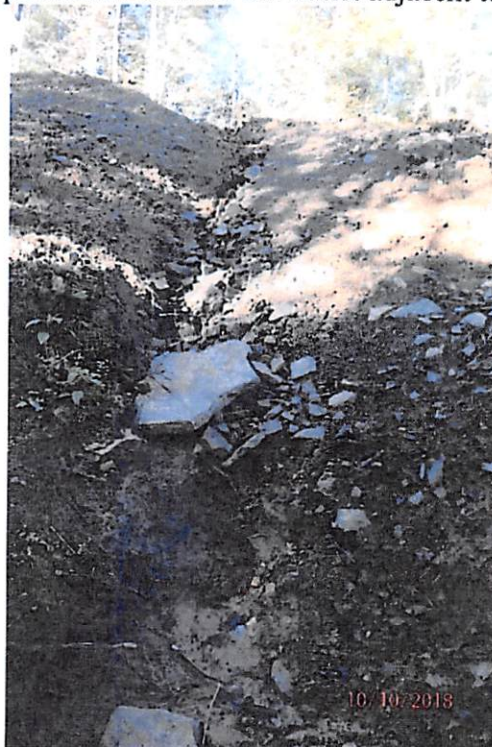
Fill slope erosion at water bar outlet adjacent to 105+00.

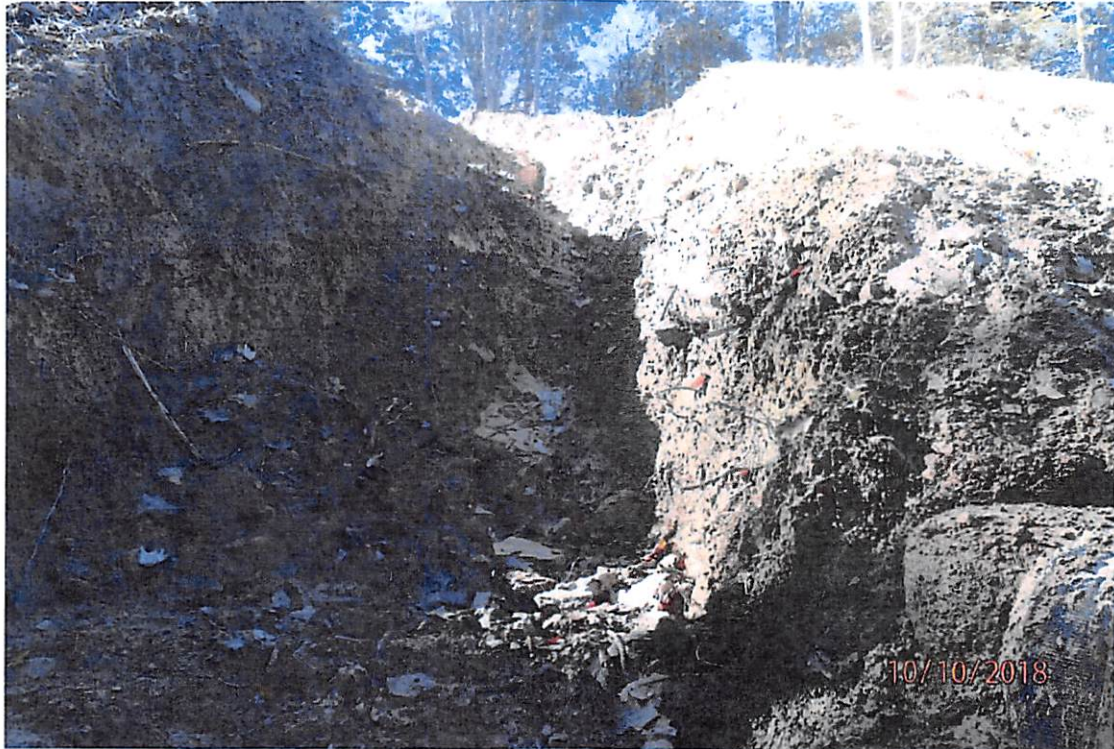
Fill slope erosion at water bar outlet adjacent to 144+00.

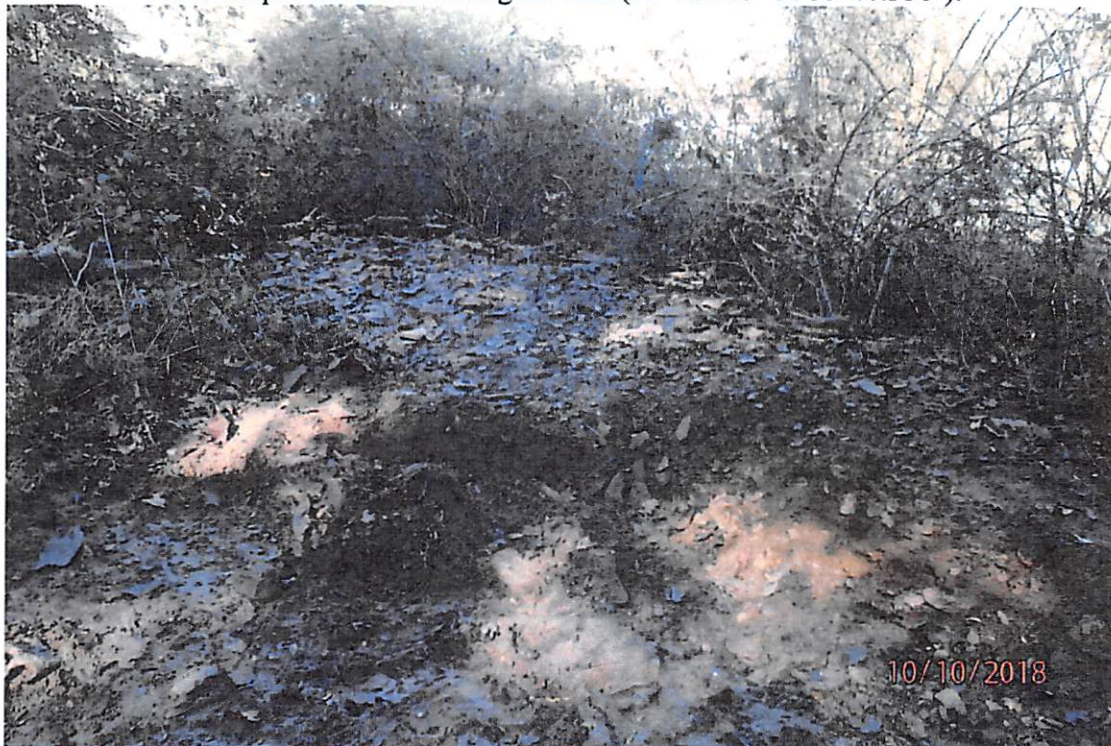
CNA deposits in UNT Morgans Run (39°18.509' X 80°40.356').

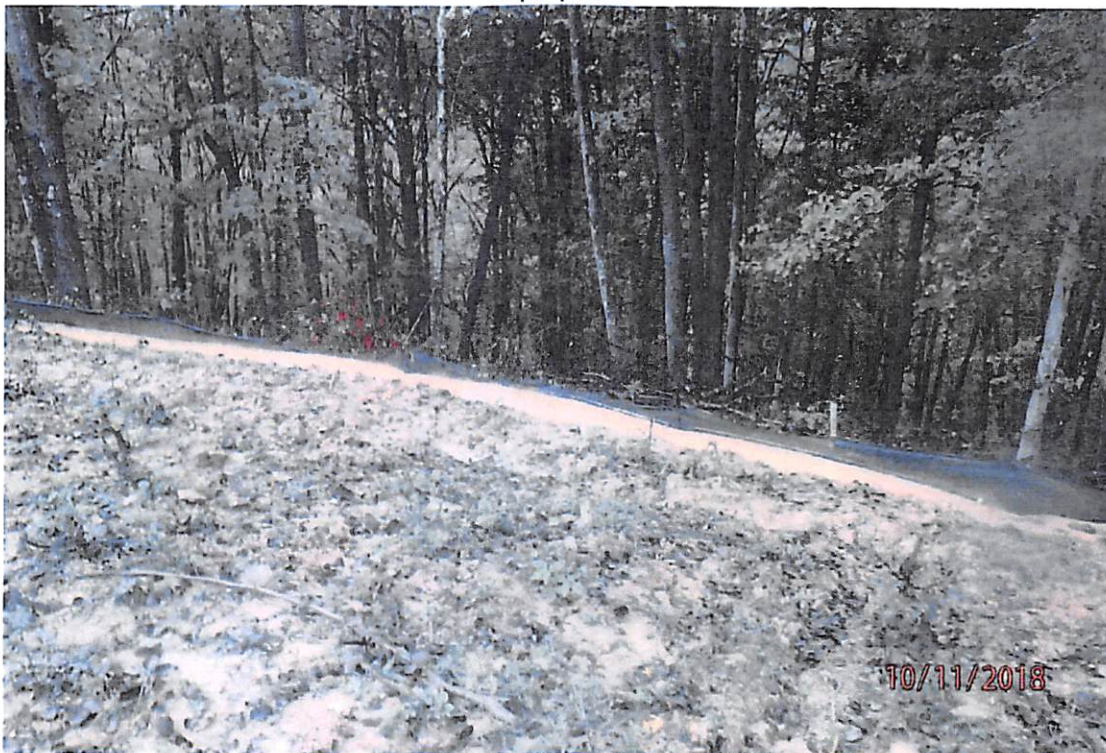
Overwhelmed perimeter controls near 820+00 due to poorly installed water bars.

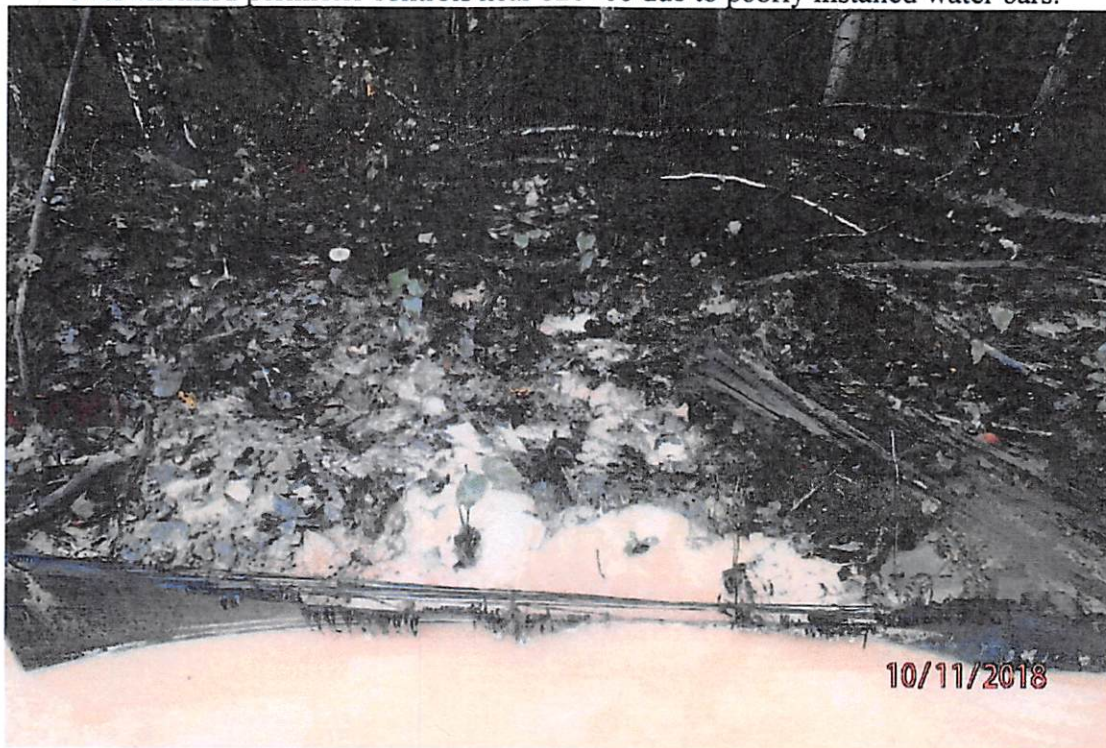
Sediment laden water bypassing perimeter controls adjacent to 820+00.

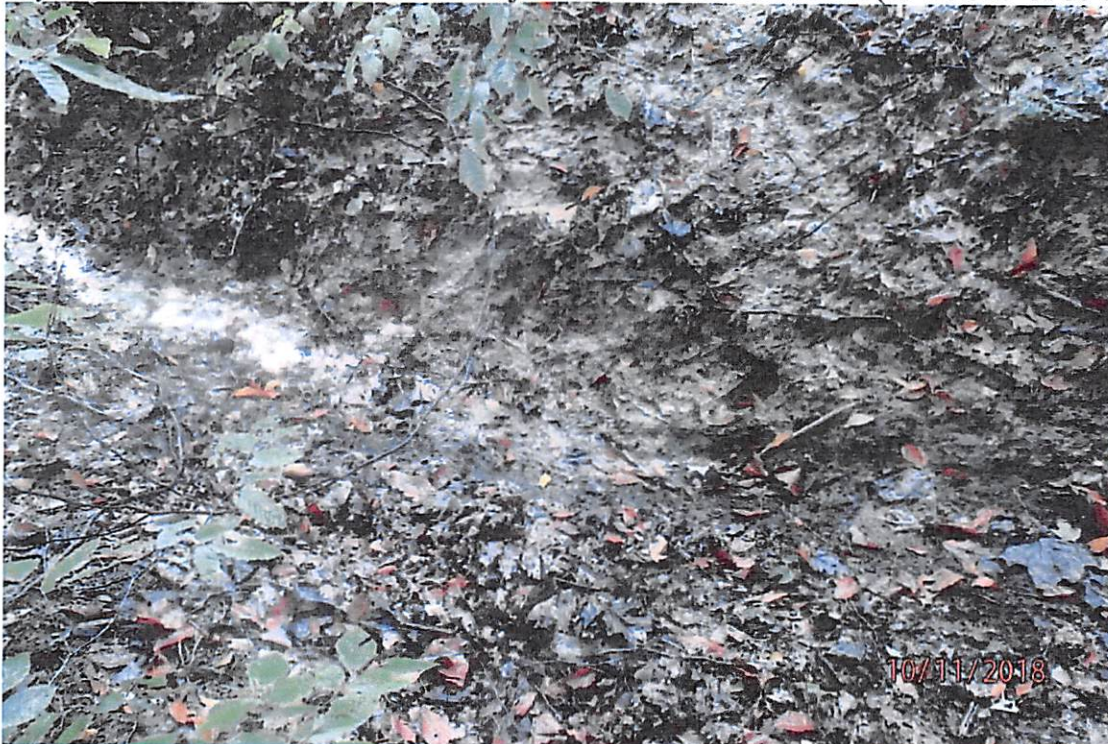
CNA distinctly visible settleable solids in UNT Beverlin Fork (39°26.320' X 80°36.101').

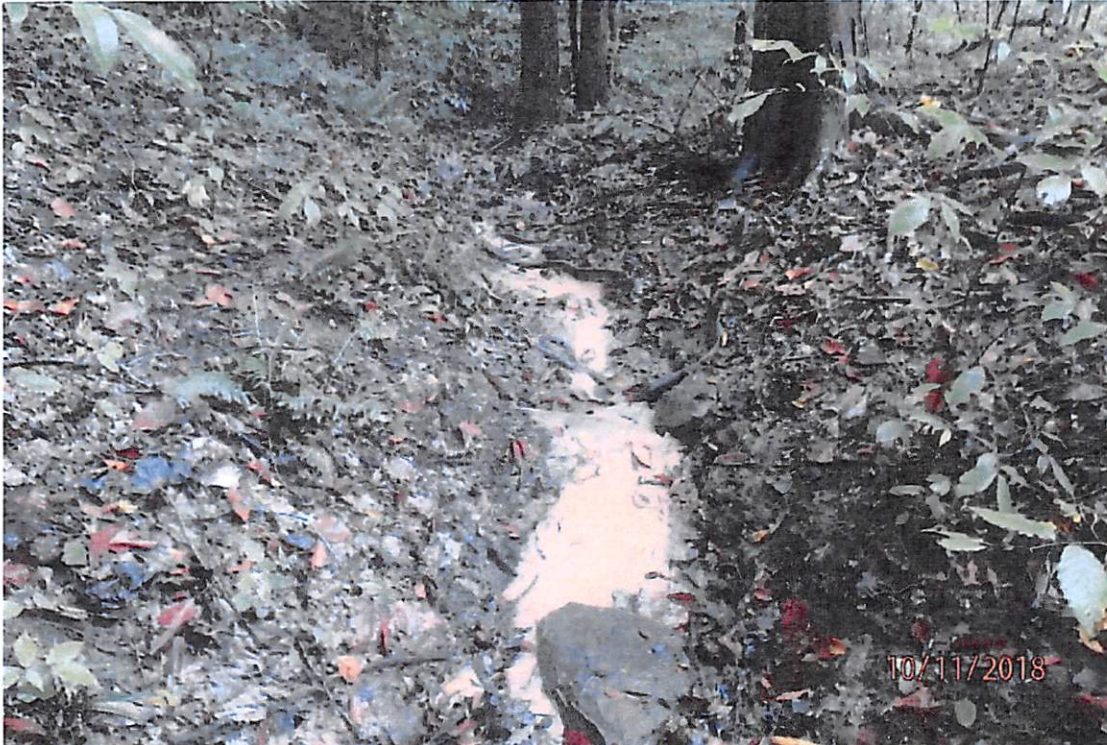
CNA distinctly visible settleable solids in UNT Beverlin Fork (39°26.320' X 80°36.101').

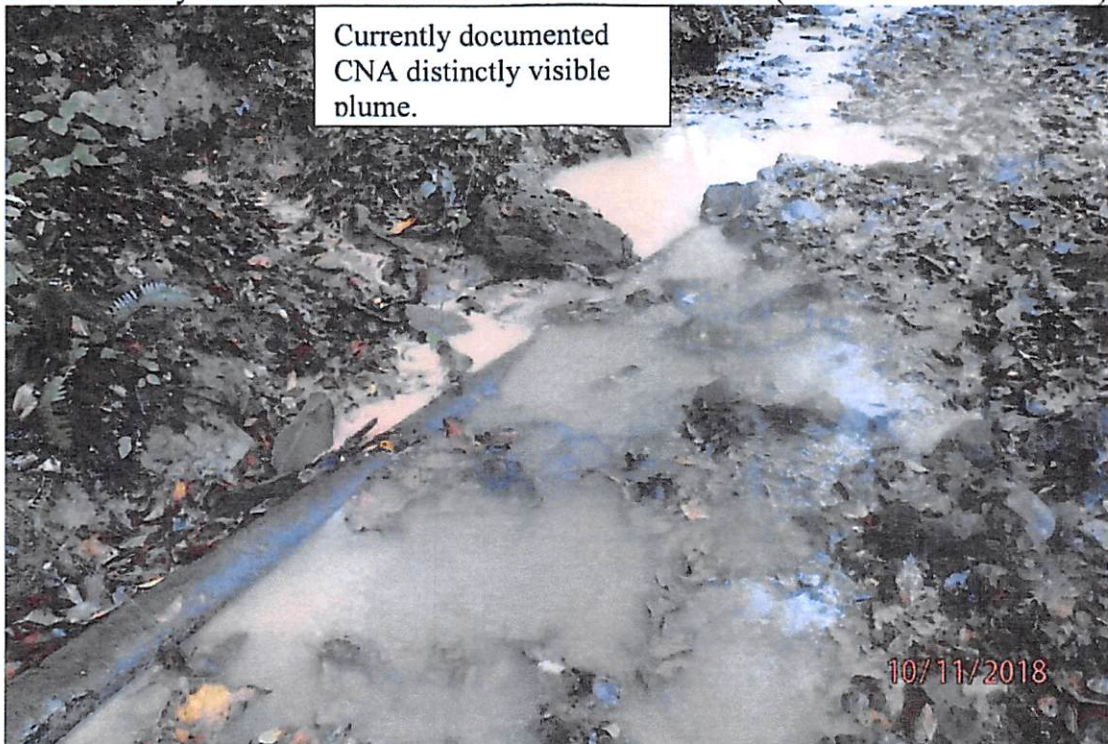
CNA distinctly visible settleable solids in UNT Beverlin Fork (39°26.320' X 80°36.101').

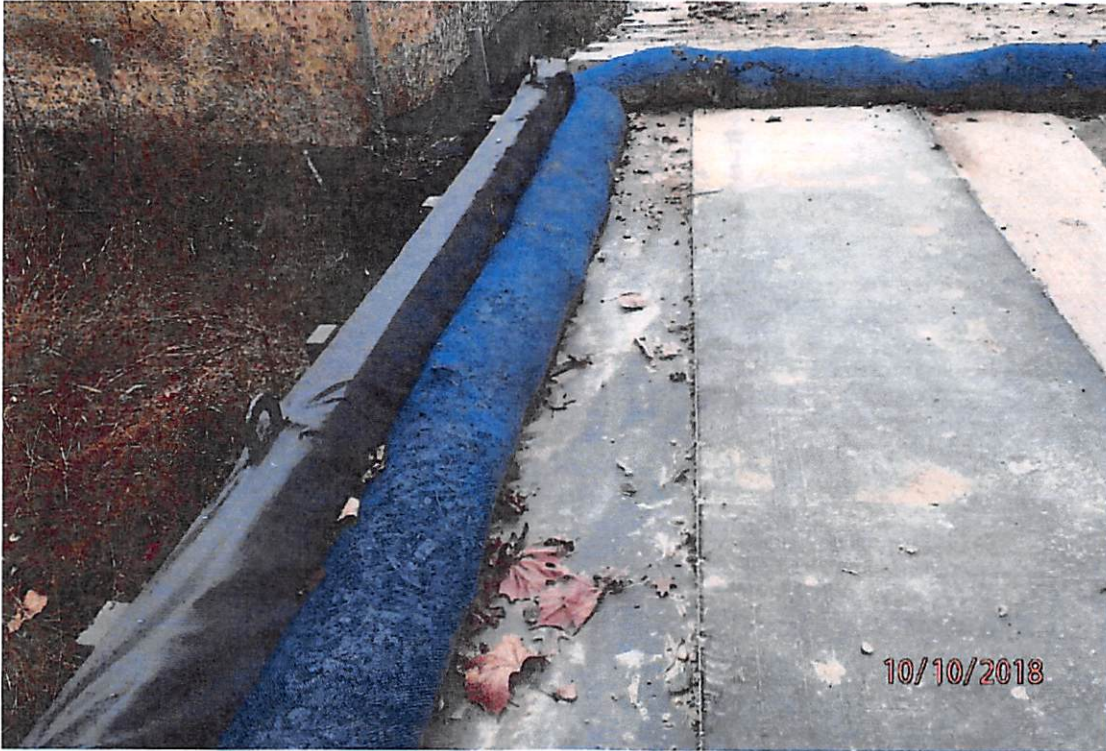
Installed bridge at crossing # 48 that lacks the top layer of timber mats as indicated in the approved SWPPP.

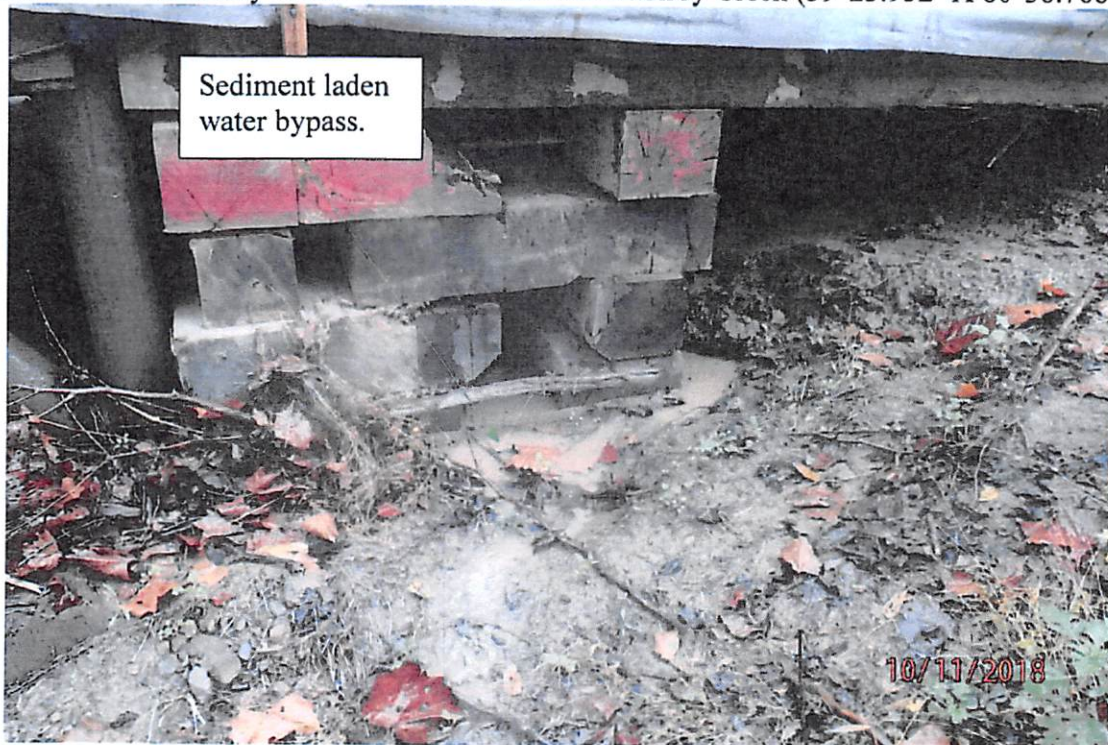
Above pictured bridge showing sediment laden water bypass.

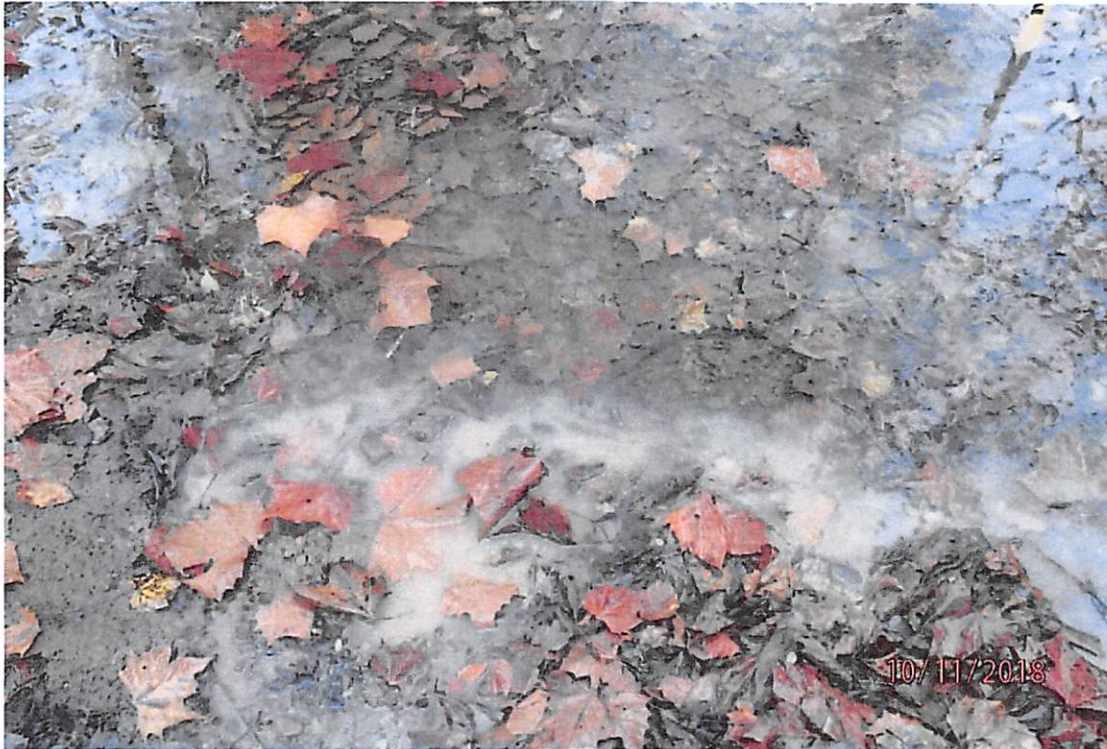
CNA distinctly visible settleable solids in McElroy Creek (39°23.952' X 80°38.768').

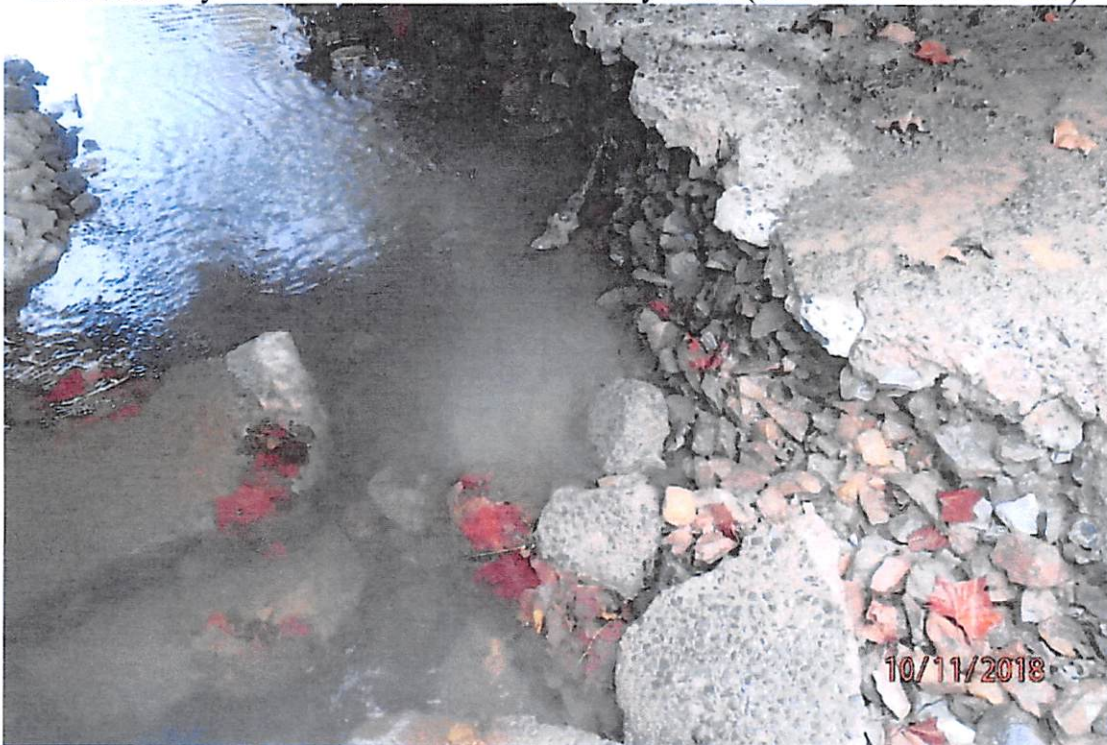
CNA distinctly visible settleable solids in McElroy Creek (39°23.952' X 80°38.768') as a result of the bridge at crossing # 54.
